## **Safety Investigation and Assessment of Dhaka-Chittagong National Highway in Bangladesh**

Shameer Saleh<sup>1</sup> and S.M.A. Bin Al Islam<sup>2</sup>

**Field of Research:** Civil Engineering

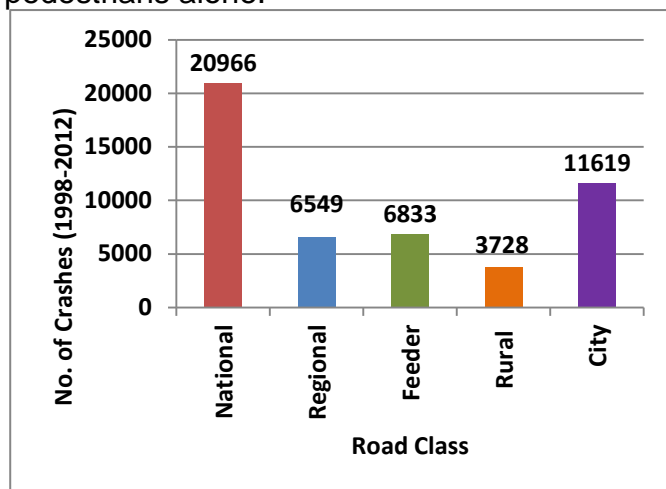
**Figure-2:** Number of Crashes (1998- 2012) by Road Class.

Rural crashes are more severe than the crashes in urban areas. Figure-2 shows that national highways hold the highest number of the total crash. Of the total reported crashes nearly 37 percent occurred on national highways. Almost 30 percent of total crashes on national highways are occurring only in 4 percent of total kilometrage. Hazards associated with roads and roadsides were particularly predominant. Studies are underway at the Accident Research Centre for identification and treatments of hazardous road locations using standard definitions, criteria and methods together with field observations so that cost effective countermeasures particularly the low cost countermeasures can be devised for highway safety improvements.

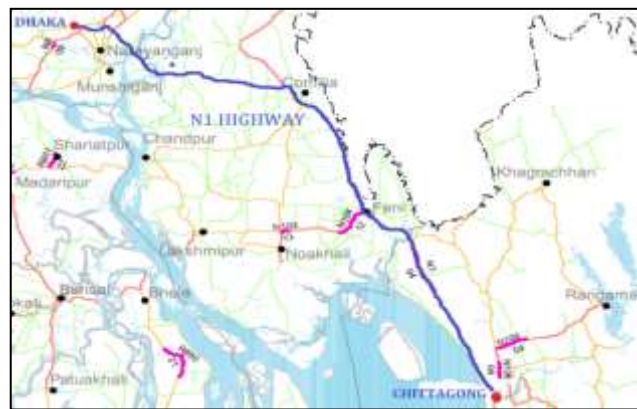
**Figure-4:** Study Route of Dhaka- Chittagong highway (N1)

The study was conducted on Dhaka-Chittagong national highway. The entire route of Dhaka-Chittagong national highway (N1) is Dhaka (N8) – Katchpur (N2) – Madanpur (N105) – Mainamati (N102) – Comilla (R140) – Feni (N104) – Chittagong (N196) – Manashertek (N107) - Satkania (N108) – Ramu (N109) – Cox's Bazar (N110) – Teknaf. On the basis of International Roughness Index (IRI), 95.67% of the highway is good, 7.4% is fair. The percent of poor section is 4.2 and has a bad section of 0.54%. The length of the highway from zero point of Dhaka to Chittagong is 264 km and the total length of the highway is about 455 km. Figure-4 shows the study route of Dhaka- Chittagong highway.

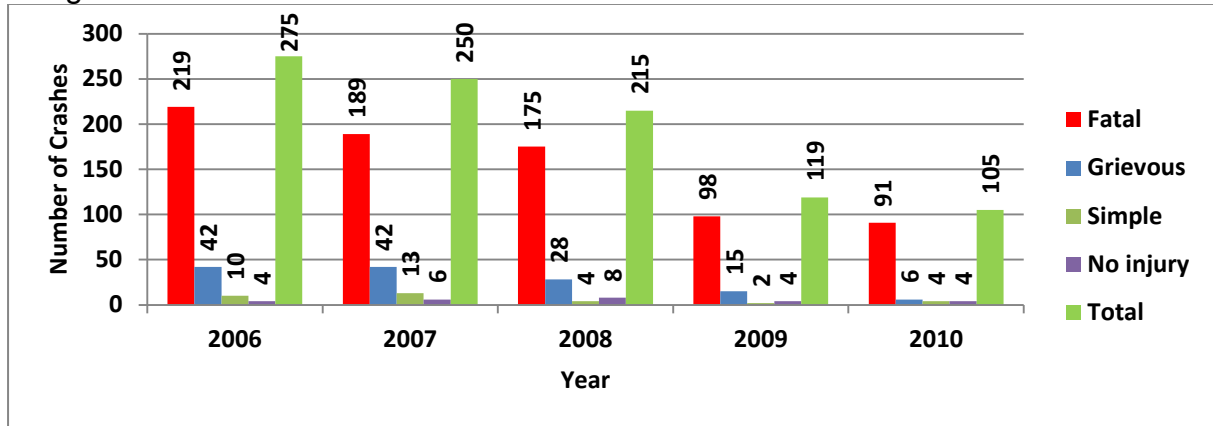
**Figure-5:** Accident Data Based on Severity Level at N1 (2006-2010)

The trends of crashes and severity levels are shown in Figure-5. The number of fatalities in 2006 was 219, but the actual number of deaths should be much higher, at least four times the number officially reported. It is clearly seen that most of the crashes that took place in N1 highway during 2006 - 2010 were fatal crashes. This

data indicates the tremendous severity of road traffic collision scenario in Bangladesh.

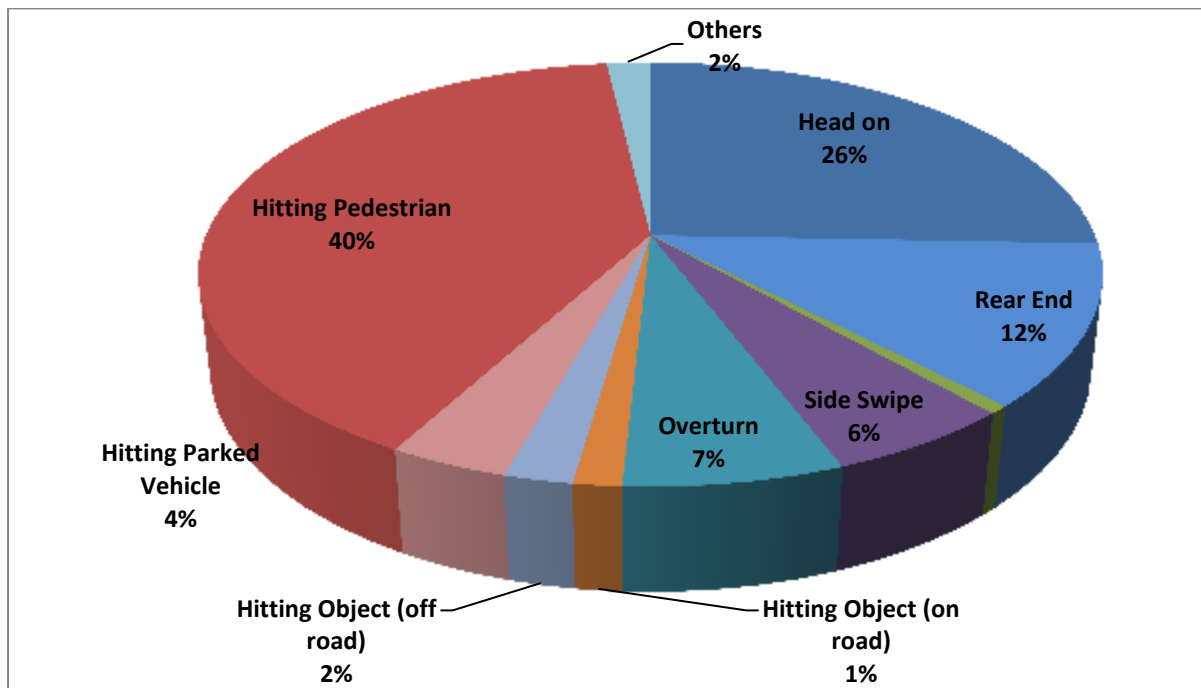
**Figure-6:** Percent Distribution of Collision Types at N1 (2006-2010)

From figure-6, it is clearly noticeable that hitting pedestrian and head on type collisions is of highest frequency (40% and 26% respectively), which means that pedestrian is the most vulnerable road user group at N1. Hitting pedestrian type collisions cause fatality of the pedestrian 95% of the time.

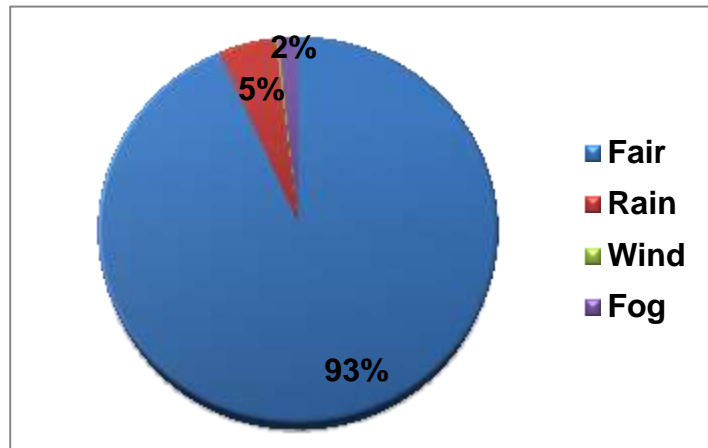
**Figure-7:** Distribution of Crashes by Weather Conditions at N1 (2006-2010)

Figure-7 shows the traffic crash situation by weather condition at the time of occurrence of traffic crashes. From the information of crashes regarding weather conditions, it is noticed that almost all the crashes occurred in fair weather conditions. So conclusion can be made that bad weather conditions such as rain, wind or fog did not have severe impacts on traffic collisions.

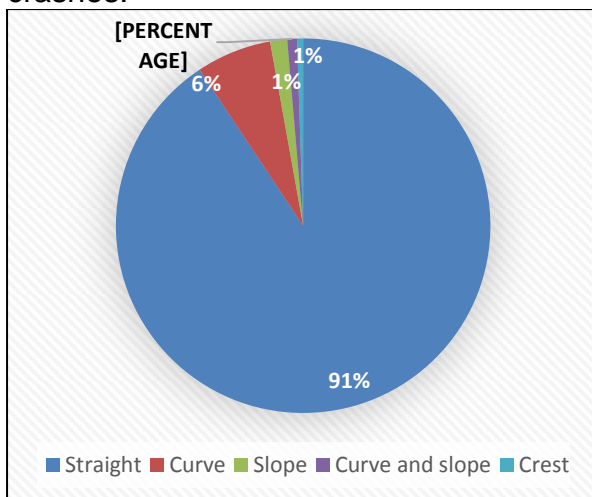
**Figure-8:** Distribution of Crashes by Road Geometry at N1 (2006-2010)

From figure-8, it is prominent that most of the collisions took place at straight portion of the roads. Though curved and sloped sections of a highway are considered to be most critical, but traffic collision scenario shows otherwise. Therefore, road geometry does not have significant effects on traffic crashes. Again from the bar diagram in figure-9, decisions can be made that number of crashes occurring at day-time is very high compared to other situations, indicating the fact that absence of lighting is not a prime cause of road traffic collisions.

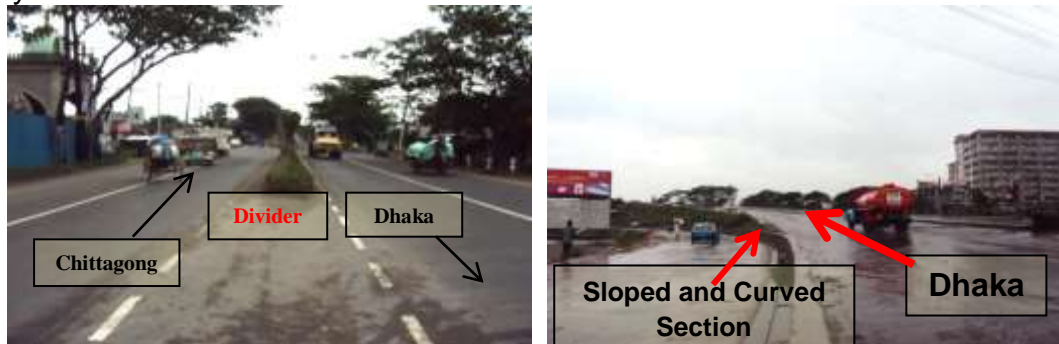
(site-1) and 12.2 km (site-2) from zero point, Dhaka. As in this case, the two sites are very closely spaced, the whole segment from Km 11.7 to Km 12.2 was considered in crash analysis. This segment lies between a petrol pump (Hazi Azimuddin and Sons' CNG Station) and a bus station (Sanarpara Bus Station). Figure-10 shows the surveyed road sections:

**Figure-10:** Road section near Azimuddin and Sons' CNG Station (site-1) (left) and road section near Sanarpara Bus Station (site-2) (Right)

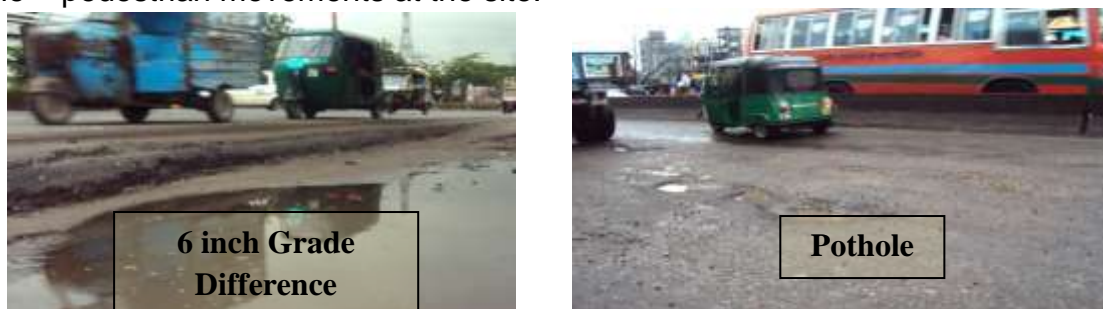
**Figure-11:** Road Surface Conditions (left- site-1 and right site-2)

Grade difference between the carriageway and the shoulder was seen. At some spots, up to 6 inches of difference in grade was observed which can cause tremendous risks and increases the chances of overturning type of collisions. Surface degradations such as potholes were frequently seen.

- Uniform width of shoulder should be provided. The shoulders should be paved for the comfort of driver;
- As in our country, underreporting of crashes is a common phenomenon, non-fatal crashes should also be considered in obtaining crash characteristics in Bangladesh;

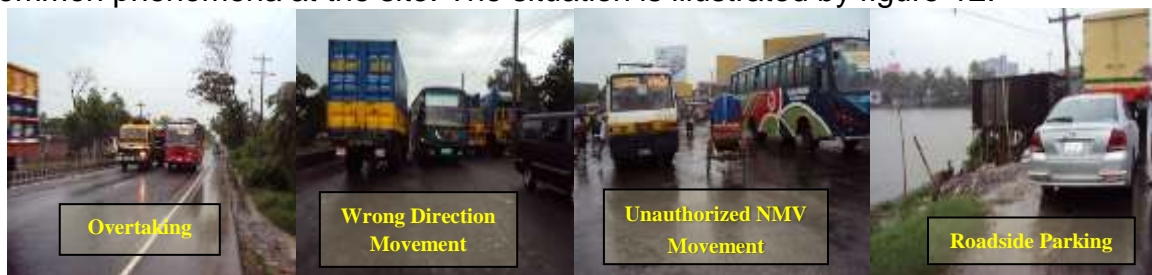
movement of vehicle was observed. Frequent overtaking and over speeding was common phenomena at the site. The situation is illustrated by figure-12.

**Figure-12:** Vehicle Movement near the Road sections

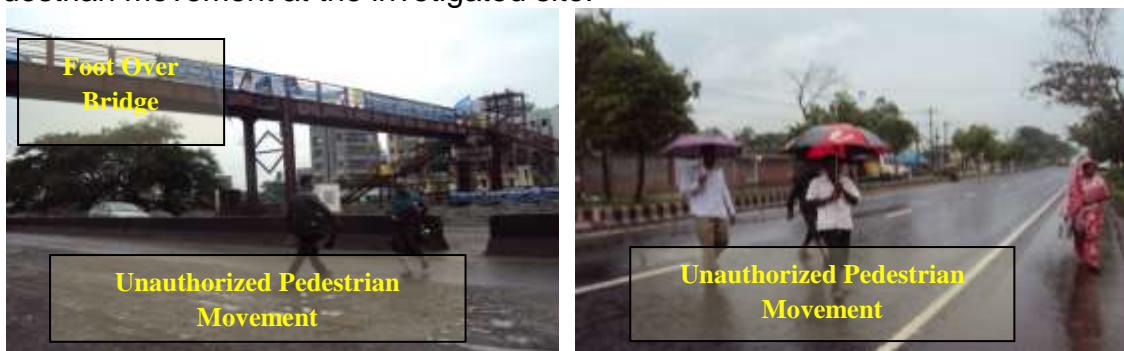
It has already been determined that pedestrian are the most vulnerable road user group in N1 highway. During site investigation, random and careless movement of pedestrian was noticed. At site 2, no pedestrian facility was seen to segregate the flow of pedestrian from vehicles moving at great speed. But near Azimuddin CNG Station (site-1), several foot over-bridges were seen. But these facilities were hardly used by pedestrians. All of the pedestrians were observed to cross the highway at the same grade as that of vehicles. Therefore, pedestrians are also responsible themselves for hitting pedestrian type crashes. Figure-13 illustrates reckless pedestrian movement at the investigated site:

**Figure-13:** Uncontrolled Pedestrian Movement at Investigated Site

- Pedestrian is the most vulnerable group at all segments of the highway investigated. Therefore, pedestrian facilities such as pedestrian barrier, overpass, underpass, zebra crossing, signalized pedestrian crossing etc. should be implemented. Grade separation of pedestrian and vehicular flow should be managed where possible to ensure safety of pedestrians;
- Speed calming devices should be placed near schools, colleges, hospitals, bazaars and residential areas to reduce over speeding;
- Relocation of bazaars, bus and CNG stands from close proximity of highway to reduce road side frictions is necessary;

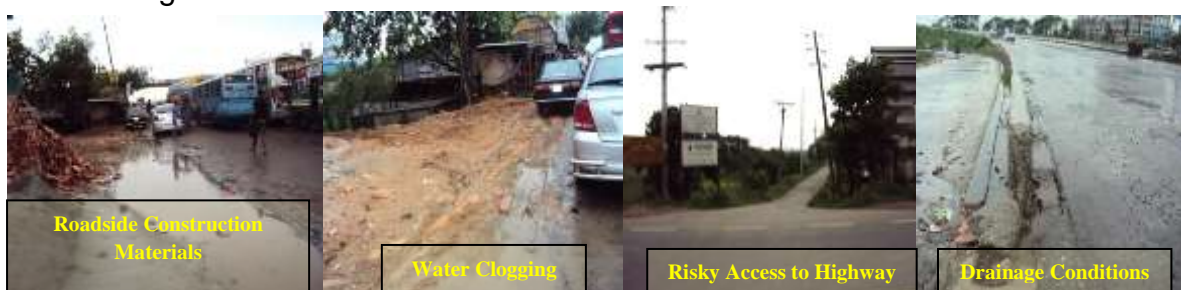
Roadside unattended construction materials, water clogging due to rain at pavement shoulders and risky access to highway from adjacent areas pose more threats to the accident situation of the dangerous site. Some additional features of the sites are shown in figure-14.

**Figure-14:** Additional features of the investigated road

- Roadway related safety initiatives have to be prioritized over behavioral or educational initiatives;
- Encroachment on roadside has to be prevented and
